## Catfield Hall Estate fens (Ant Broads, Norwich)

Visit June 5<sup>th</sup> 2013

Utrecht, June 20<sup>th</sup> 2013

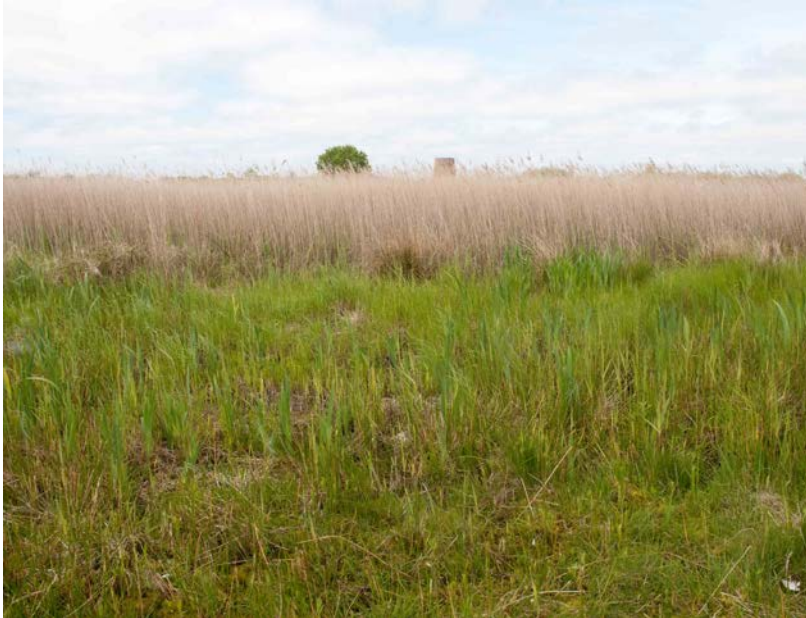
Middle  
Marsh

A field with *Phragmites australis* (low, ca. 1.4 m), *Eriophorum angustifolium* and *Calamagrostis* with at many locations the mosses *Sphagnum cf fimbriatum* and *Aulacomnium palustre*. These mosses grow there recently; there was no layer of dead mosses beneath. First groundwater had pH of 4.85 and an Electric Conductivity (EC) of 130  $\mu\text{S}/\text{m}$ . In the middle of the marsh is a "pond" where the water has pH = 5.56 and EC = 95 (sample 1). Around this pond is a wet zone with some forbs e.g. with *Iris pseudacoris* and *Menyanthes trifoliata*. Here the water at surface had pH = 5.0 and EC = 225 (sample 2). In some ditches the species *Stratiotes aloides* is present; the distribution of this species in the Netherlands of mostly linked to nutrient-rich conditions. The ditch at the boathouse close to the elevated area was the location where *Hottonia palustris* was growing (indication of seepage of groundwater); digging the ditch created an opening in clay layer? Here the water in the ditch was pH = 7.5 and EC = 700 (sample 3).

The observations indicate that the buffered conditions with high groundwater table are not met in most fen areas at Catfield. Especially in the Middle marsh and the Mill marshes are many indications that acidification and desiccation are problems for the vegetation. Another indication is that the stems of *Phragmites australis* remain short. Not only the presence/absence of plant and moss species indicate this change, but also the measurements in the field with low pH values and low conductivity of the water support this hypothesis.

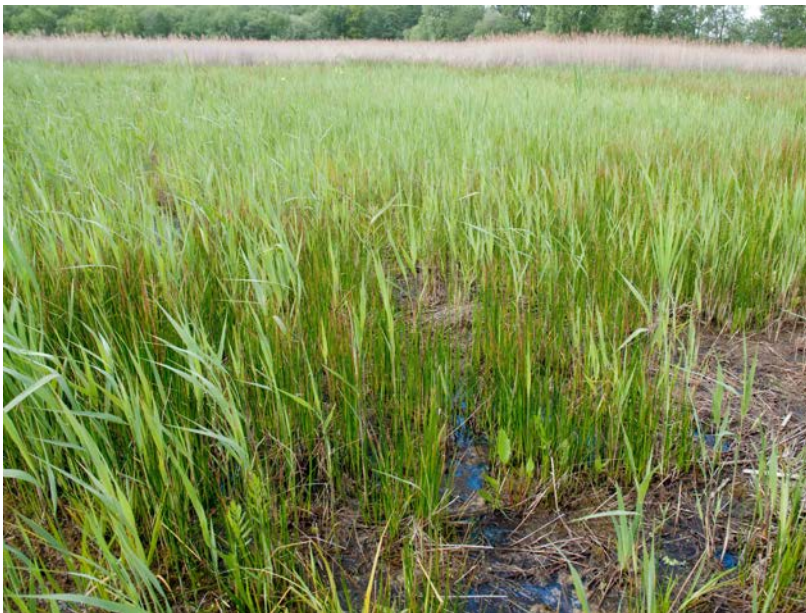
North  
Marsh  
north

This marsh differs totally from the other ones. The reed marsh harbours many other species; *Phragmites australis* is frequent but is mixed with e.g. *Peucedanum palustre*, *Alisma plantago-aquatica* and *Carex pseudocyperus*. Indicators for higher pH values and seepage of groundwater were present: *Ranunculus lingua*, *Equisetum fluviatile* and *Juncus subnodulosus* for the plant species, and the moss species *Calliergon cordifolium* and *Mnium rugicum*. There are spots in this marsh where the seepage can be observed with/by the film of iron-bacteria on the top layer. Here the water had a pH = 6.9 and EC = 850 (sample 4).

As a reference how a correct fen marsh maintains its conditions, the North marsh north can be applied. At this marsh the diversity and structure in the vegetation seems correct. The measured values in pH and EC support this observation.
