# Snipe Marsh 26<sup>th</sup> September 2014

## Water Level Management on Snipe Marsh

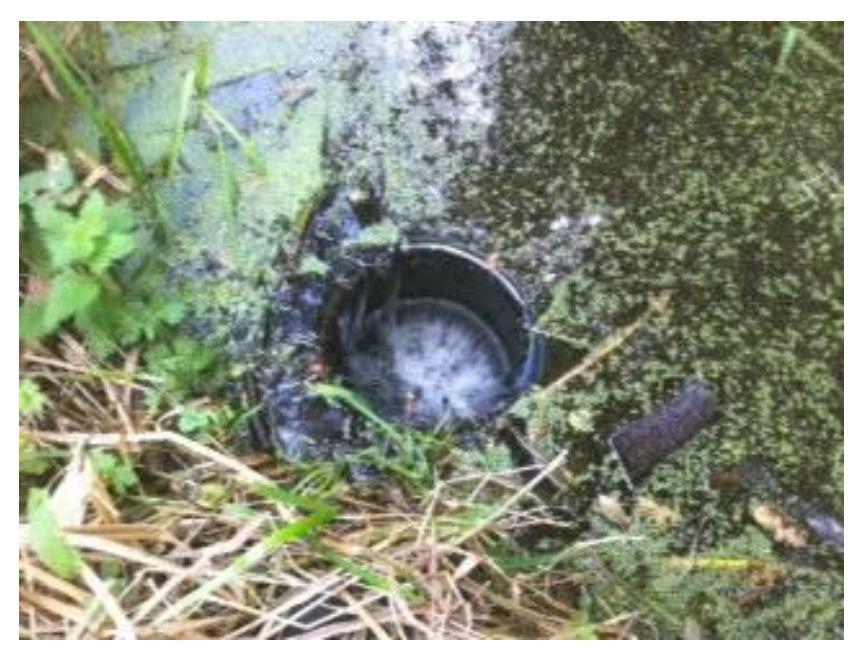
Snipe marsh water level control- marked 3 on map

There are two water control pipes in Snipe Marsh, marked "2" & "3" on the map.

These maintain the ditch level at the desired level. Both myself have never known the water level to fall below this level as water is always entering the marsh.

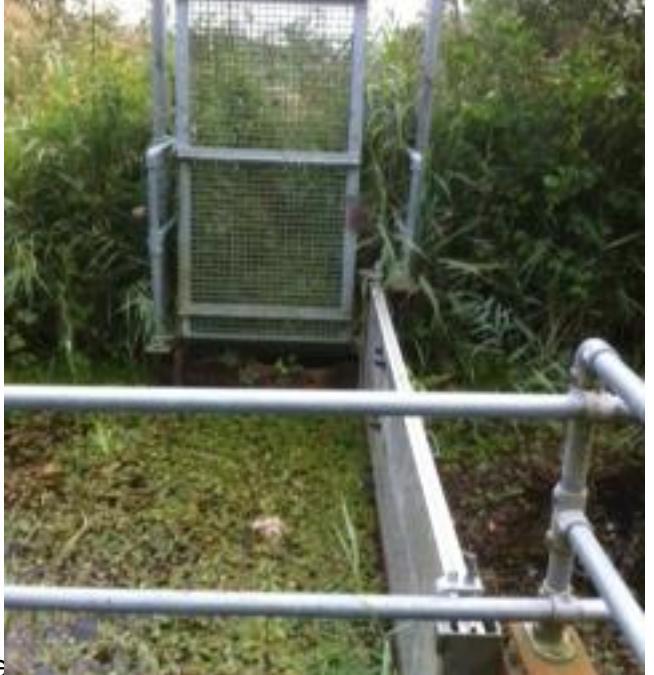
According to the Broads Authority Site Management Plan of How Hill 2011/12-2015/16 by Erica Murray this sluice ("4" on map and picture below) was installed by BESL as part of the flood defence work in 2009. This was a replacement for the previous sluice and the site has been in isolation from the river since 1992. The management plan aims to keep water levels at marsh level from January to April and no more than 45cms below marsh level between June and October. This fits with observations on Snipe Marsh of the water levels in the remainder of the marsh being 4-6 inches lower than the water control pipes.

I have visited the sluice 4 times since 21st August and on every occasion the river water level was higher than the internal levels by 4-10 inches.

water le

Main sluice with higher

Erica Murray and Sue Stephenson (Broads Authority staff)) told and myself that the main sluice "4" on the map was installed to prevent dirty water entering the site and now the water in the river was much cleaner they did not know why the sluice was in place. This is different to Erica Murray's site management plan but the reluctance to remove the sluice is clearly having an effect on water levels on How Hill and Snipe Marsh.

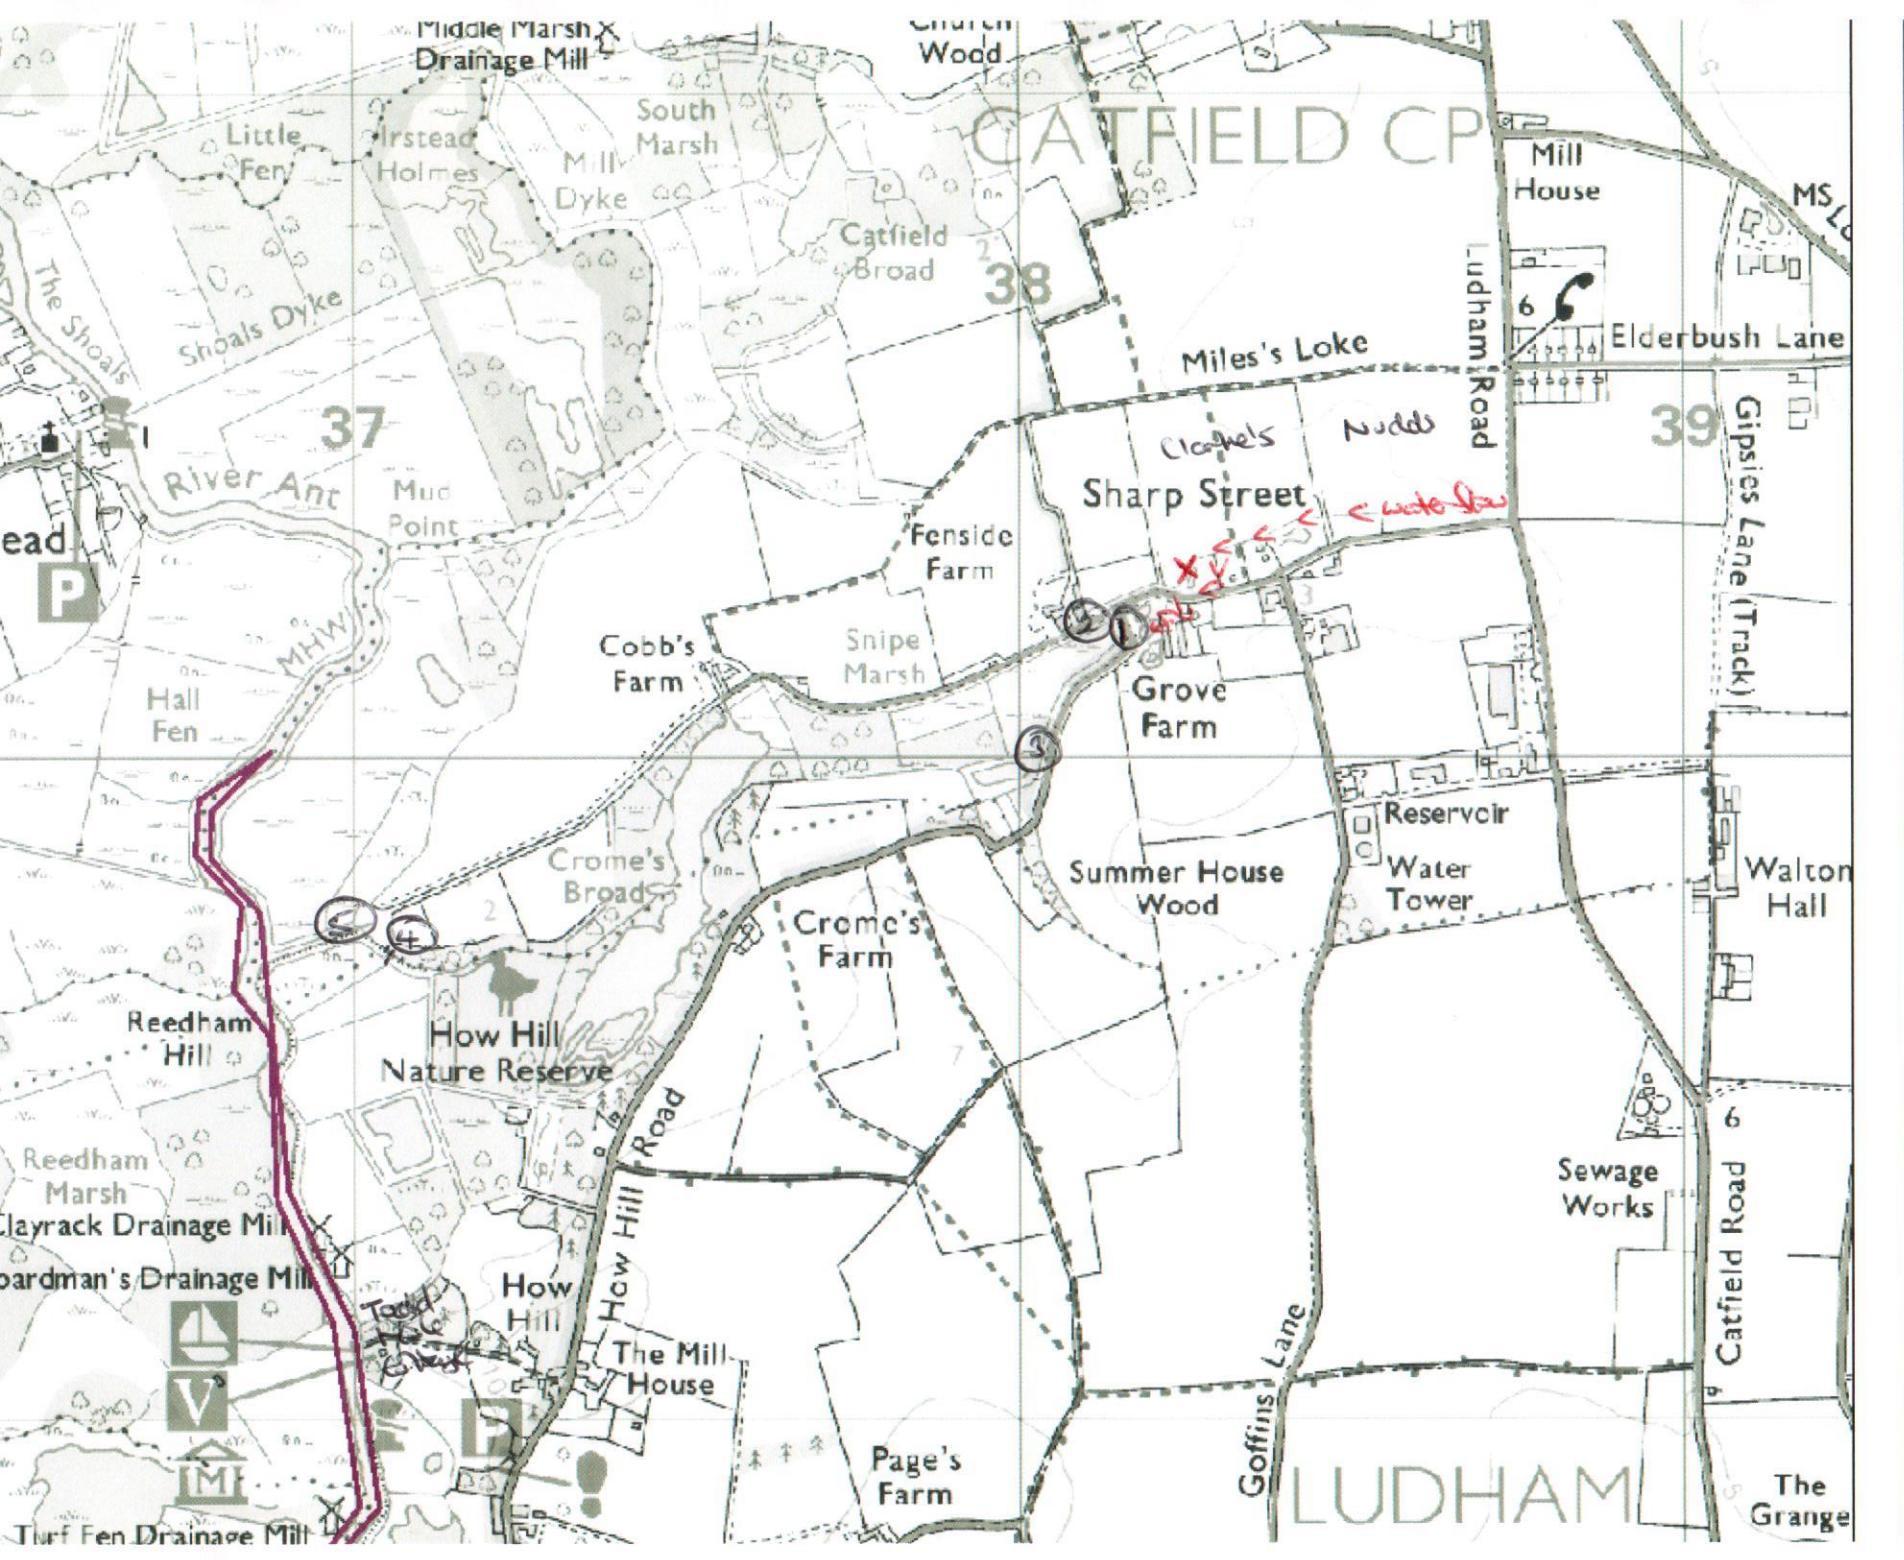
Surface water enters Snipe Marsh via a pipe under the public road marked "1" on the attached map. This water mainly comes from 8 land drains in the fields Clarkes and Nudds plus some water from the houses and roads alongside Sharp Street. These land drains run all year and the ditch always has water in it. The land drains are also picking up surface lateral water from the East side of Ludham Road. The flow of water in these drains does not appear to be affected when my Ludham Road borehole is pumping. I believe that this water is from soil above the clay layer, which is why pumping does not affect the flow.

On 26<sup>th</sup> September the water level in the piezometer called "Clarke's" (marked with a red cross on the map) was 1.85m below the top of the piezometer. The water level in the adjacent ditch was about 0.92m below the top of the piezometer. This piezometer is 15m deep and certainly below the clay layer but the piezometer water level was 0.93m below surface water level.
