Water Resource Operations & Hydrology East Anglia Area - Essex, Norfolk & Suffolk

Groundwater Summary for Temporary Report Sites Report for February 2021

Environment
Agency

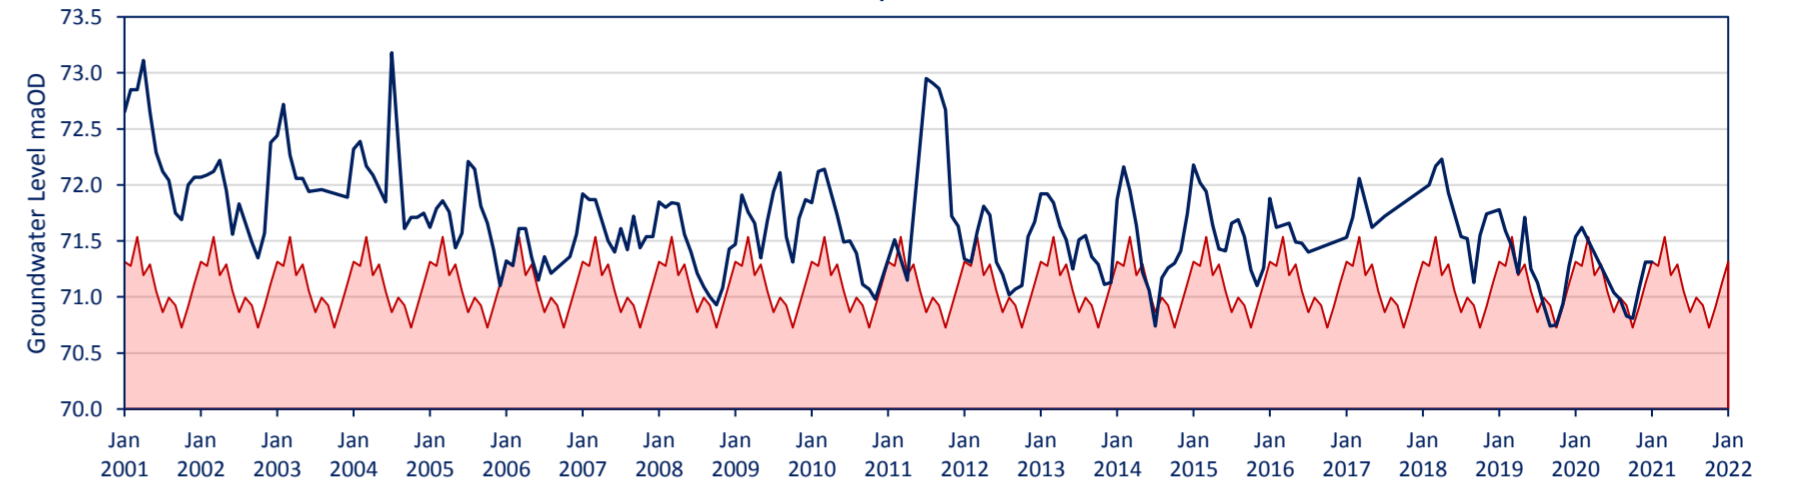
Essex Chalk Great Bradley OBH 20 Year Level Trend
